United States Department of Agriculture
Forest Service

National Technology & Development Program • 7700—Transportation Mgmt • 1177 1810—SDTDC • December 2012

Decision Analysis Guide for Corrugated Metal Culvert Rehabilitation and Replacement Using Trenchless Technology

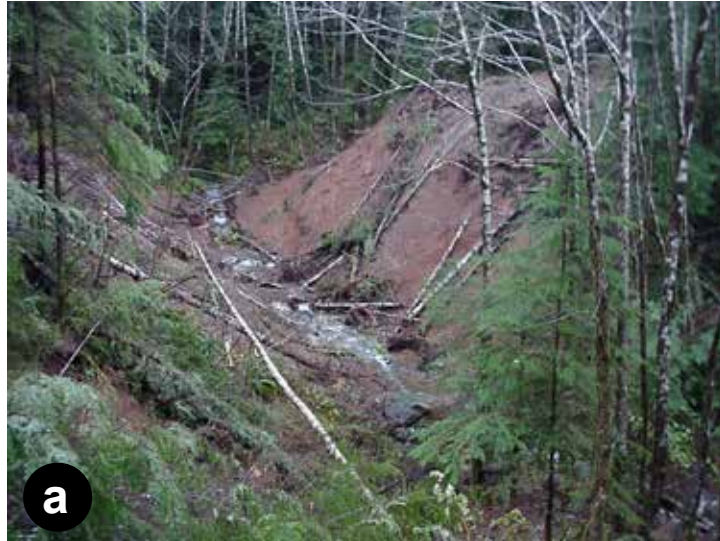
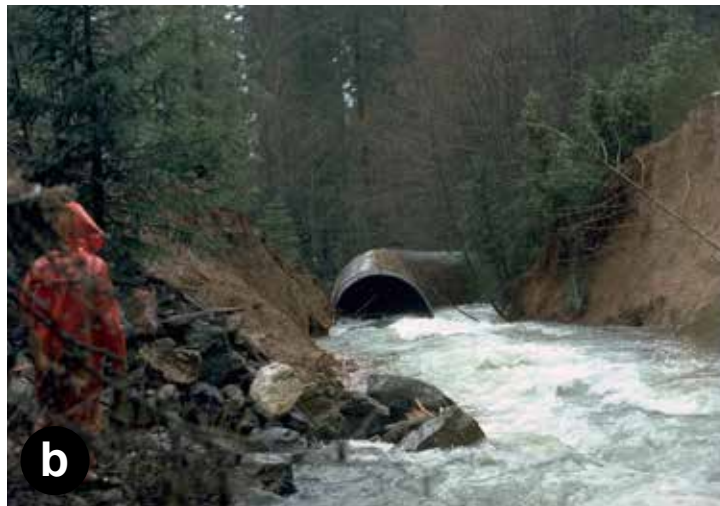
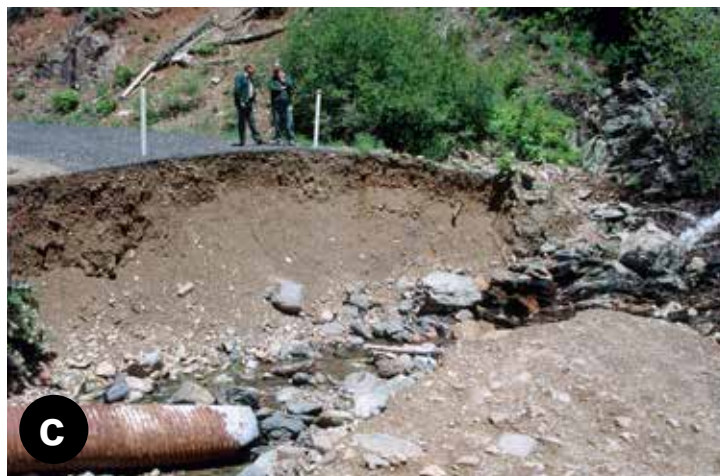
Figure 1—Culvert blowouts—a. Culvert blowout along a national forest road, b. Culvert blowout (Gordon Keller, Forest Service), c. Culvert blowout Cold Water Creek (Gordon Keller, Forest Service).

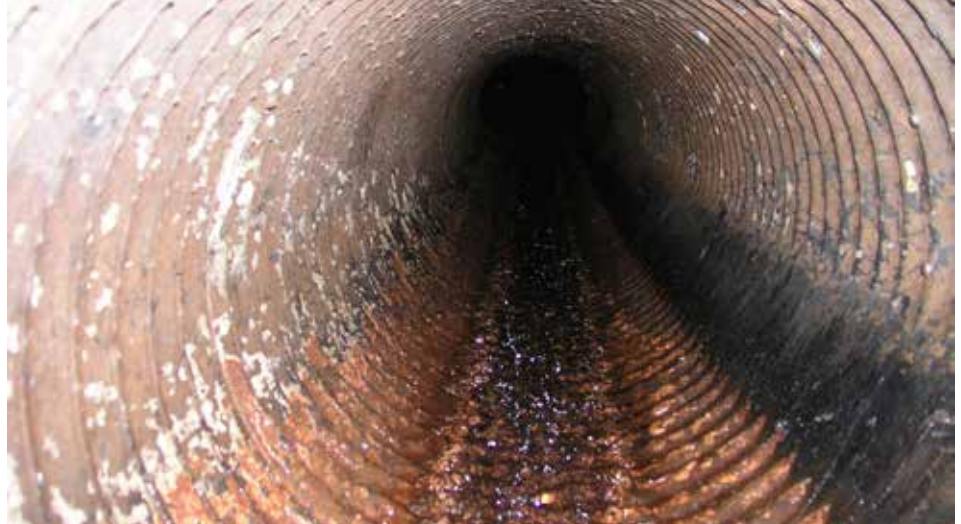
Minor corrosion and abrasion can cause superficial rust and minor pitting and can be rehabilitated with a nonstructural method (figure 3a).

Figure 3a—Minor corrosion occurring in a corrugated metal culvert.

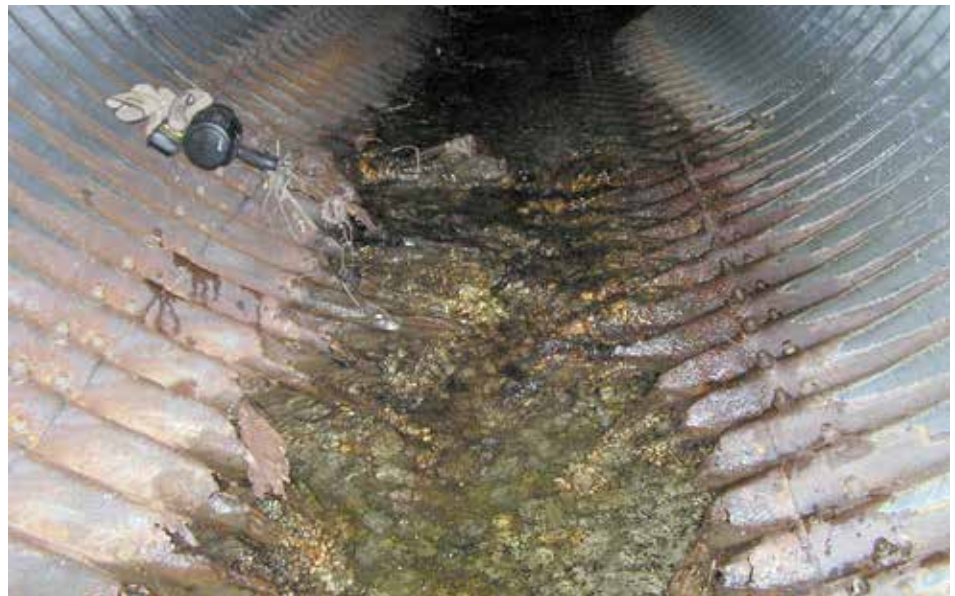
Medium corrosion leads to scattered heavy rusting and deep pitting and can be addressed with a semistructural rehabilitation method (figure 3b).

Figure 3b—Medium corrosion occurring in a corrugated metal culvert.

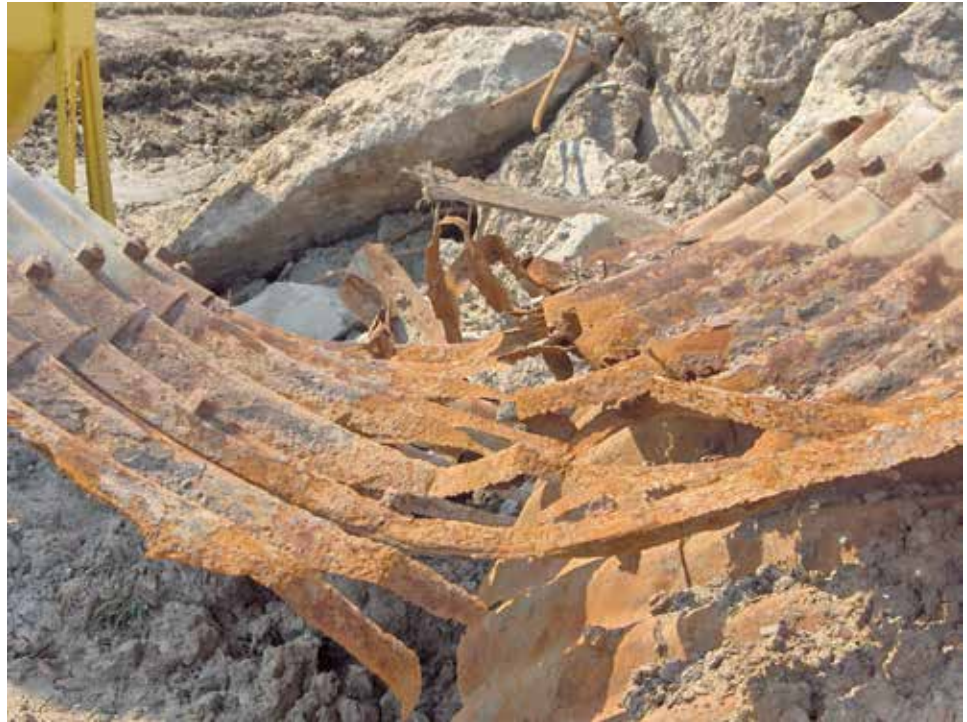
Major corrosion can cause structural failure and collapse due to extreme rusting and deep pitting perforations and needs a fully structural rehabilitation method (figure 3c).

Figure 3c—Major corrosion occurring in a corrugated metal culvert (D.A. Van Dam and Associates and Ohio Department of Transportation).

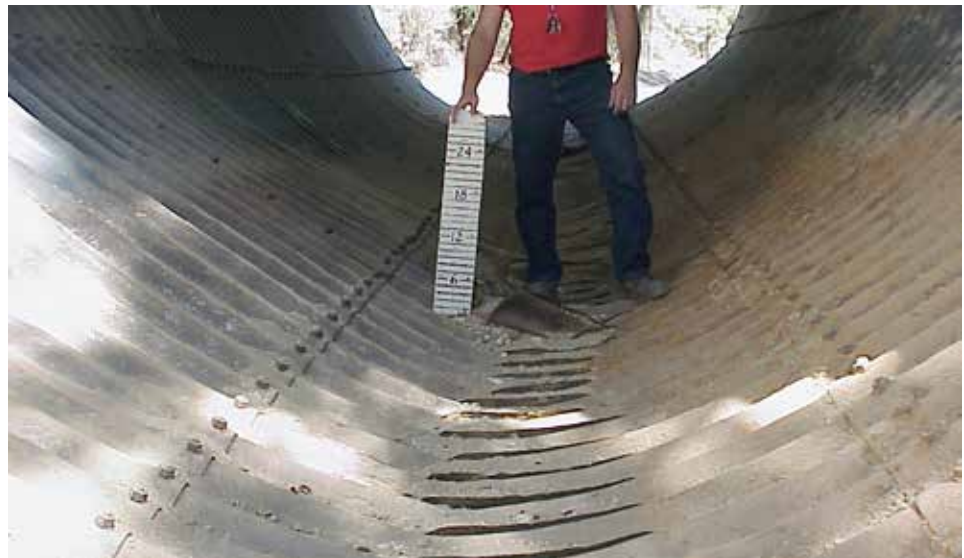
A culvert pipe that has a corroded or abraded invert (the bottom of the culvert) (figure 4) or a pipe that is severely pitted and perforated still may be capable of supporting its backfill and cover, but it constitutes a high risk of failure and requires a prompt repair or replacement (National Cooperative Highway Research Program 1978). Significant flattening of the invert also will require attention to prevent further deterioration.

Figure 4—Invert deterioration occurring in a corrugated metal pipe (Caltrans).

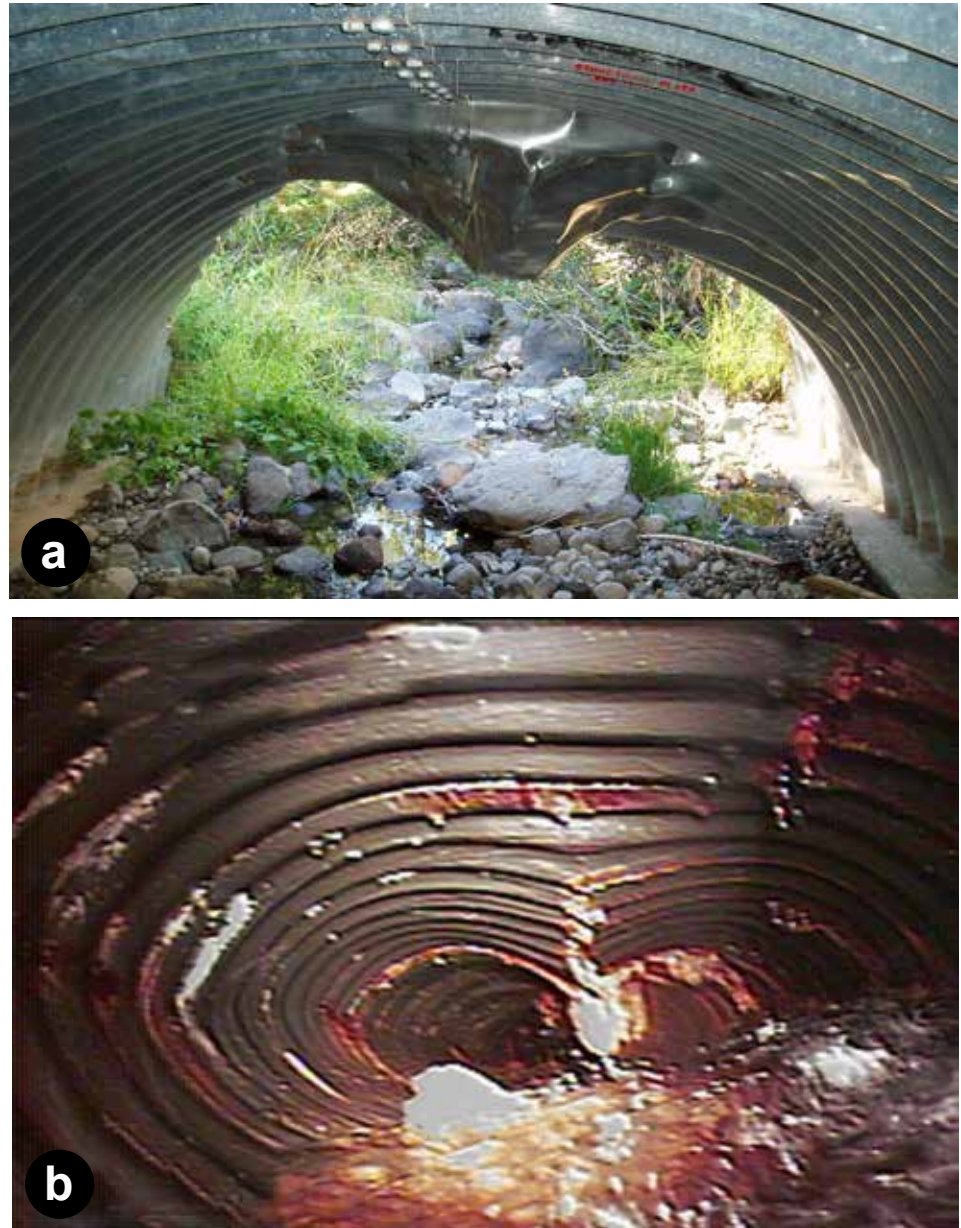
If a culvert is partially or fully collapsed, as shown in figure 5, then lining methods will not be applicable and an inline replacement, such as pipe splitting or a complete open-cut installation will be required.

Figure 5—Collapsed/punctured corrugated metal pipe—a. Punctured corrugated metal pipe (Gordon Keller, Forest Service), b. Collapsed corrugated metal pipe.

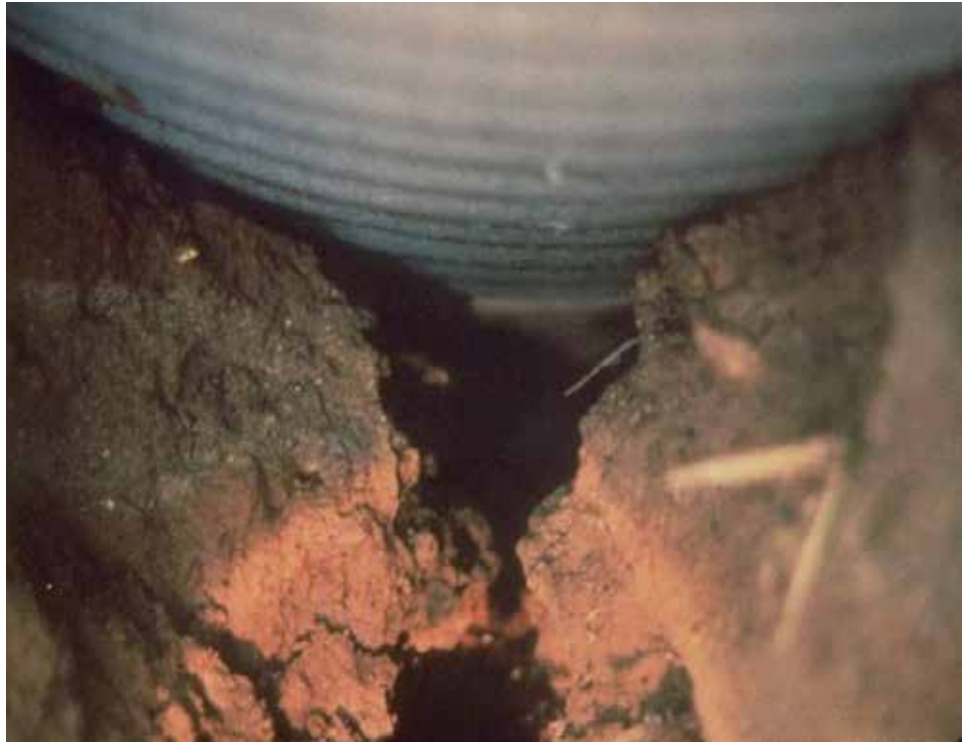
Erosion voids, sometimes referred to as piping (figure 6), can spread and reach the ground surface. Not only does this adversely impact the stability of buried metal culverts, but it can pose a potential loss of life if a void forms under a pavement. Typically, preventative measures include proper compaction practices and seepage collars.

Figure 6—Piping beneath a culvert.

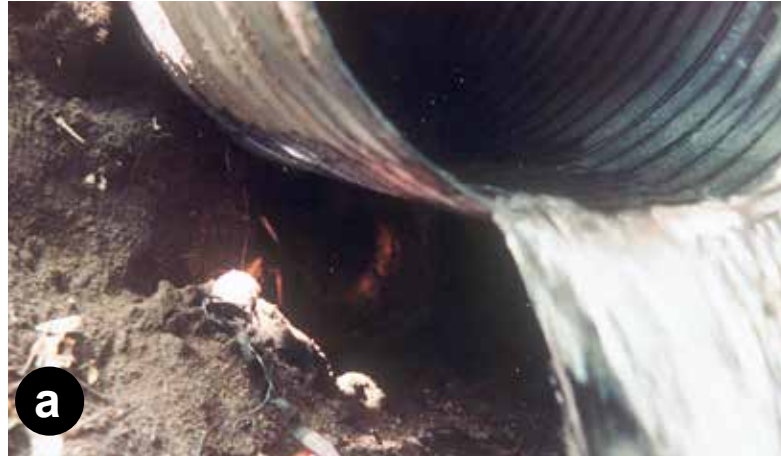
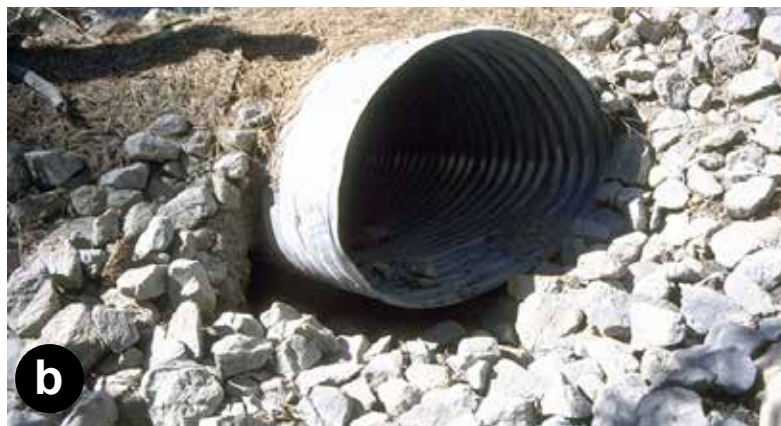
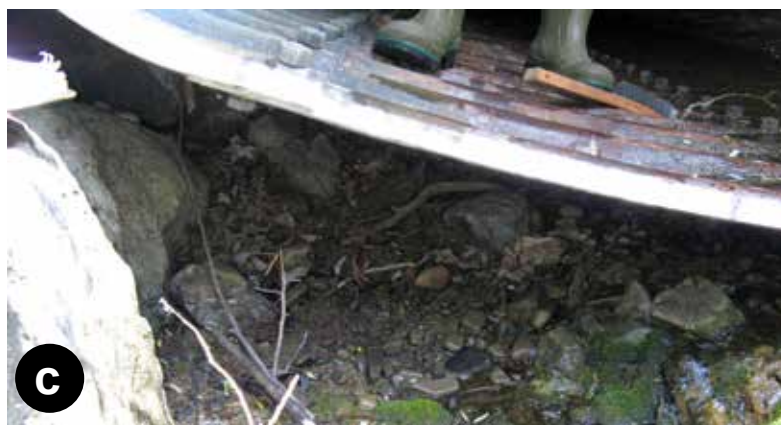
A normal outcome of metal culvert pipe corrosion that has produced perforation is undermining (i.e., the formation of erosion voids in the embedment soil below and beside the structure) (figure 7). These voids, typically adjacent to severe corrosion, are due to ingress of water through the corroded zones and infiltration of backfill material under hydrostatic pressure. Undermining results in a loss of soil support for the culvert. Without an adequate soil envelope around the pipe, metal culverts have relatively little bending stiffness and are likely to deflect and exhibit shape distortion or sags and joint opening.

Figure 7—Undermining of a corrugated metal pipe—a. Voids around a corrugated metal pipe (Gordon Keller, Forest Service), b. Undermining (Gordon Keller, Forest Service), c. Undermining (Caltrans).

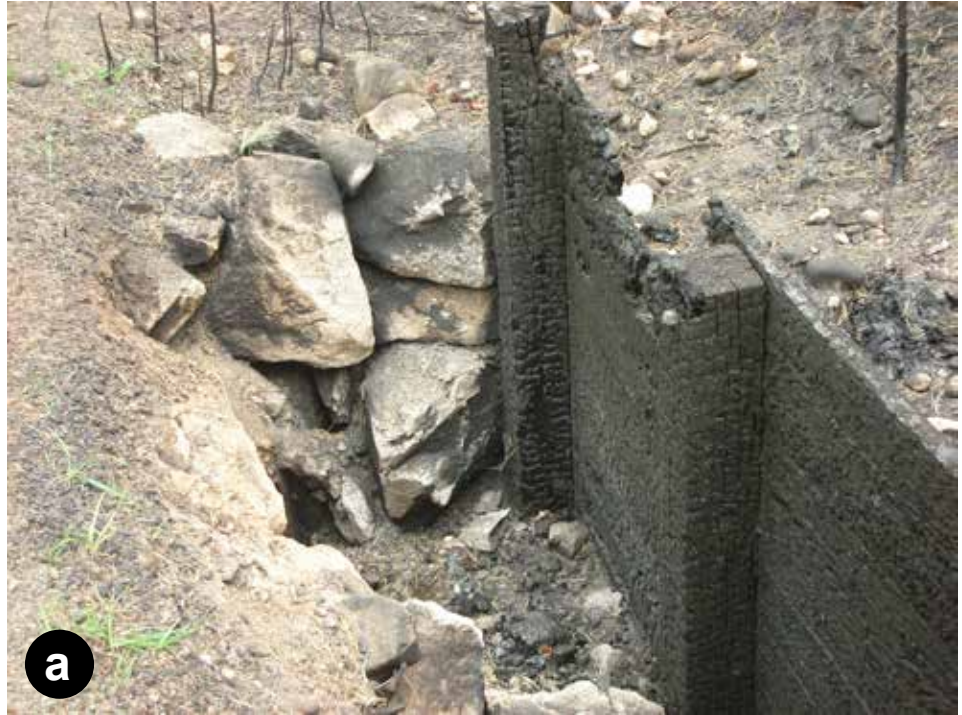
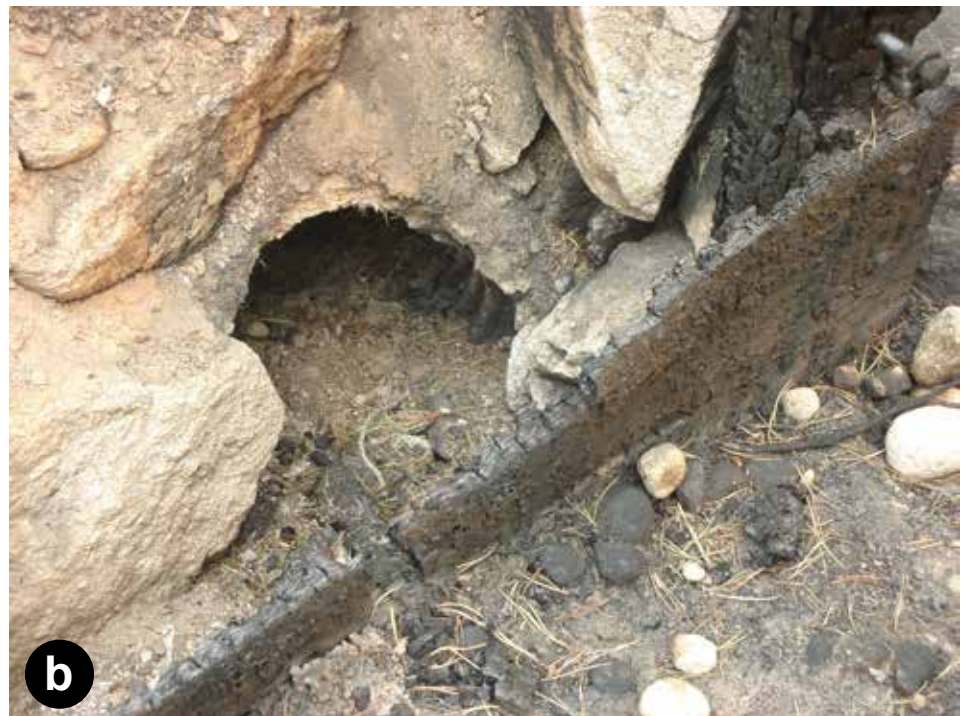
In 2007, the Cascade Complex fires in the Payette National Forest in Idaho resulted in the destruction of 142 high-density polyethylene culverts ranging in diameter from 18 to 36 inches, 41 wood culvert inlet headwalls, and 50 high-density polyethylene culvert downspouts (figure 9). The Forest Service and the FHWA recommend concrete or masonry headwalls for flammable plastic culverts and liners in forest environments where fire is a possibility.

Figure 9—Cascade complex fire, Idaho (Charlie Showers, Forest Service)—a. Catch basin with timber lag headwall. b. Burned off culvert inlet in a catch basin with timber lag headwall, top view.

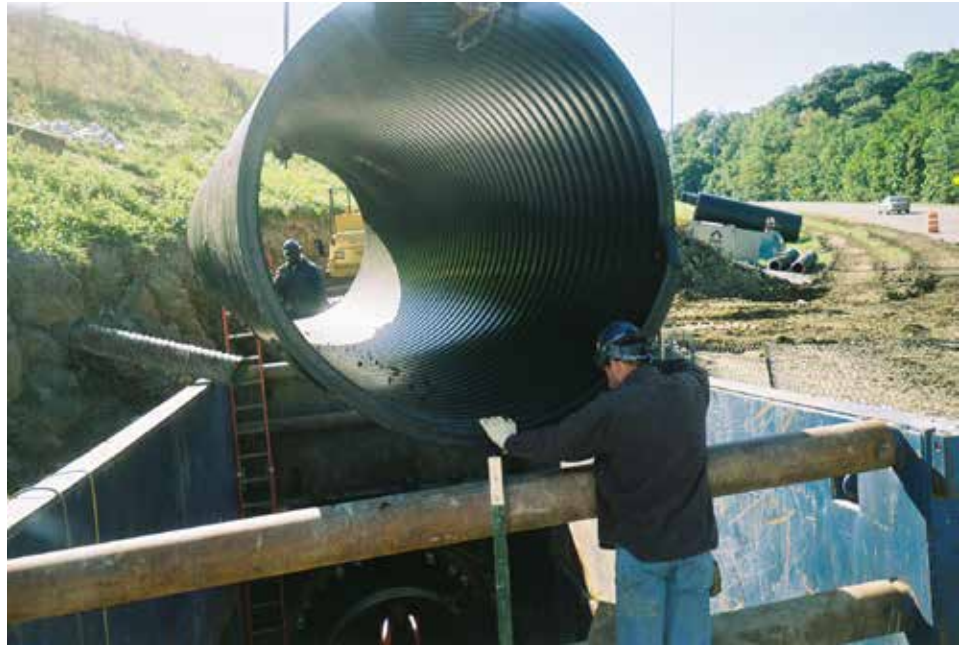
Ohio Department of Transportation reported sliplining a corrugated metal pipe culvert under a highway with a pressure-rated high-density polyethylene culvert liner. The existing culvert was 102 inches in diameter and 835 feet long, and the high-density polyethylene pipe was 72 inches in diameter. The slipliner pipe was delivered to the site in sections, and after aligning, the individual segments were welded from the inside. After welding, the pipe was inserted into the culvert and the annular space grouted.

Figure 10—Sliplining corrugated metal pipe in Ohio (D. A. Van Dam & Associates).

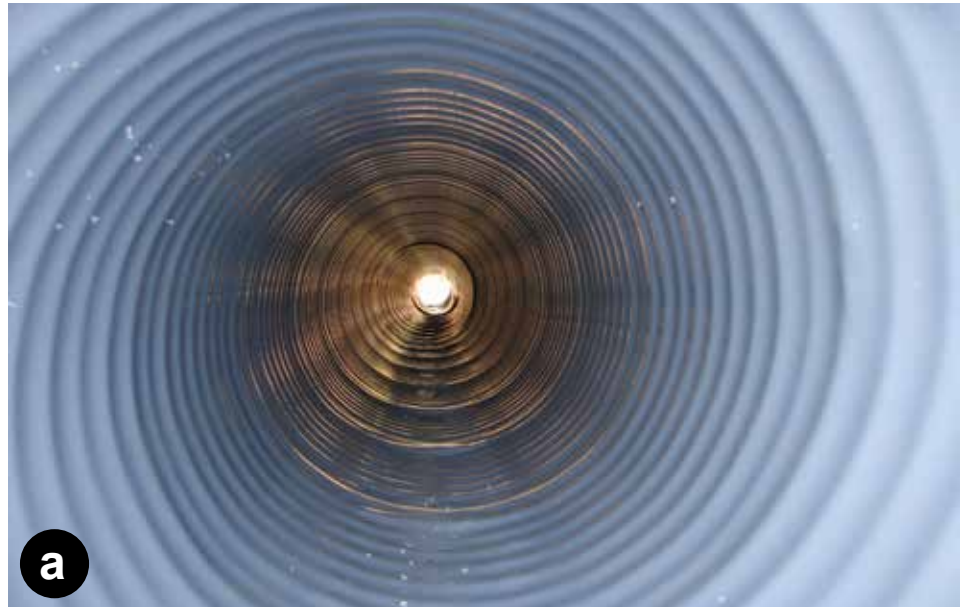
Fold-and-form liners are made of polyvinyl chloride. For installation, the liner is deflected into a U shape during the manufacturing process so it can be easily pulled inside the pipe; steam or air pressure is used to expand the liner to fit closely the size and shape of the host pipe (figure 13).

Figure 13—Installation of fold-and-form liner (Ultraliner)—a. Looking down the center of a culvert in which a fold and form liner has taken on the shape of the host culvert. b. The folded pipeliner is pulled through a culvert under a road, then the pipeliner is plugged and expanded under steam pressure.

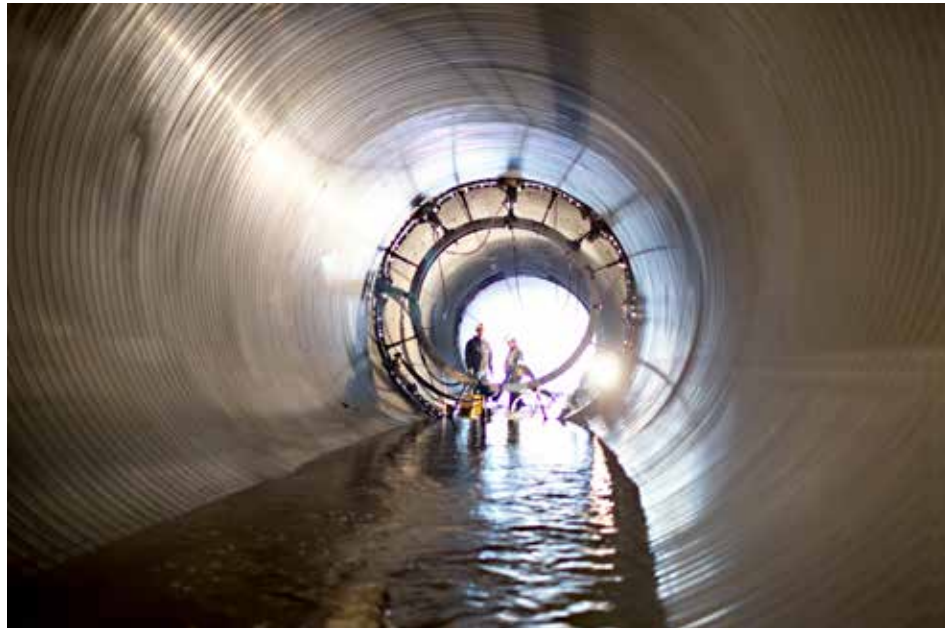
Spiral-wound liners are fabricated in the field from a continuous plastic strip with male and female edges. During the winding process, the male and female edges self-interlock and form a leak-tight joint. With this method, an annular space between the host pipe and the liner is created, which generally is grouted with a cementitious material. The strip can be made of polyvinyl chloride (with or without steel reinforcement) or high-density polyethylene, can have external ribs to increase the stiffness, and can anchor in the cement grout injected in the annulus space between liner and host pipe.

Figure 14—Spiral winding of a 14-foot corrugated metal storm sewer (Sekisui SPR).

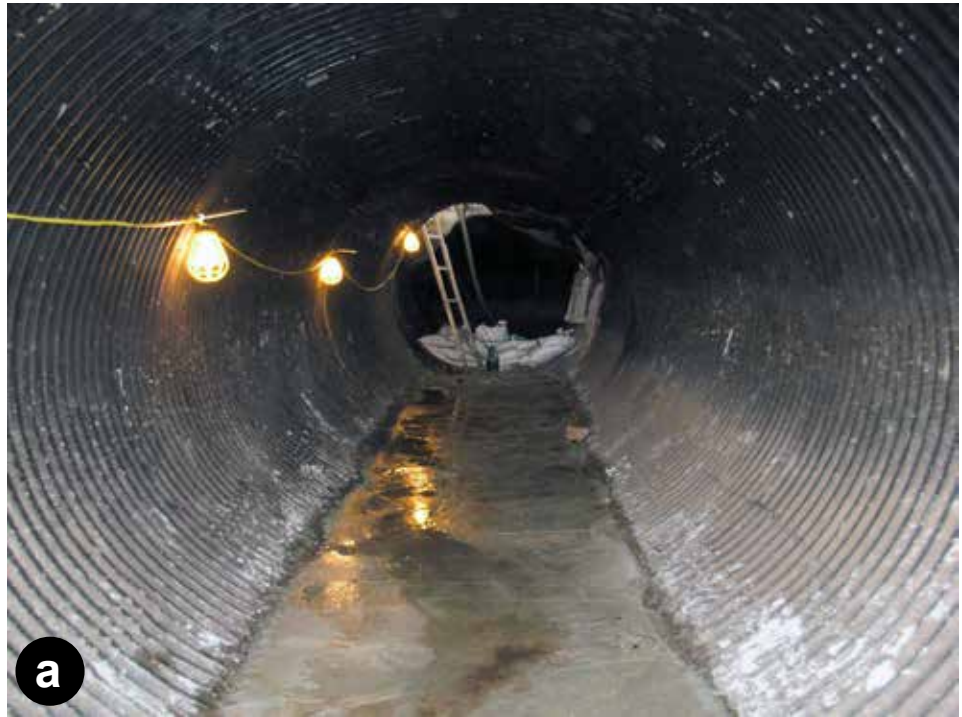
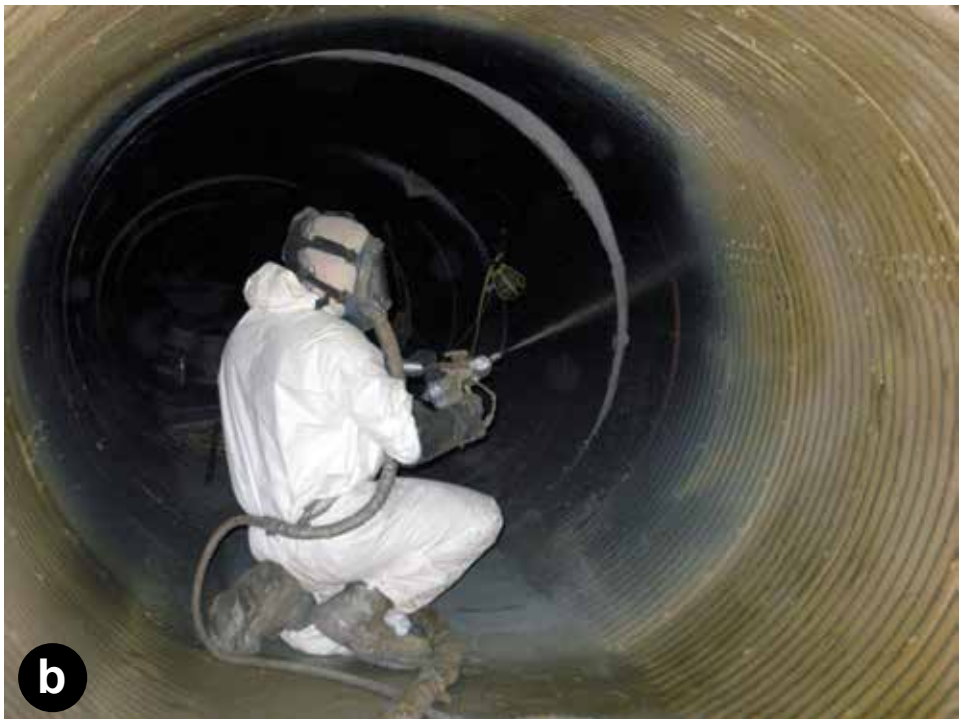
Figure 16—Polyurethane spray (Sprayroq, Inc.)—a. Culvert in Norristown, PA, before rehabilitation, b. Culvert during application of SprayWall® (Sprayroq Inc).

In 2007, in Norristown, PA, a galvanized corrugated steel pipe culvert 60 inches in diameter and 1,800 feet long was spray-relined with polyurethane. The lining was sprayed in one coating (thickness 300 mils) with a proprietary heated plural component spray system. The application required a very clean and very dry surface. The applied surface preparation procedure is proprietary for the systems used (Jerry Gordon, Sprayroq, Inc., personal communication).

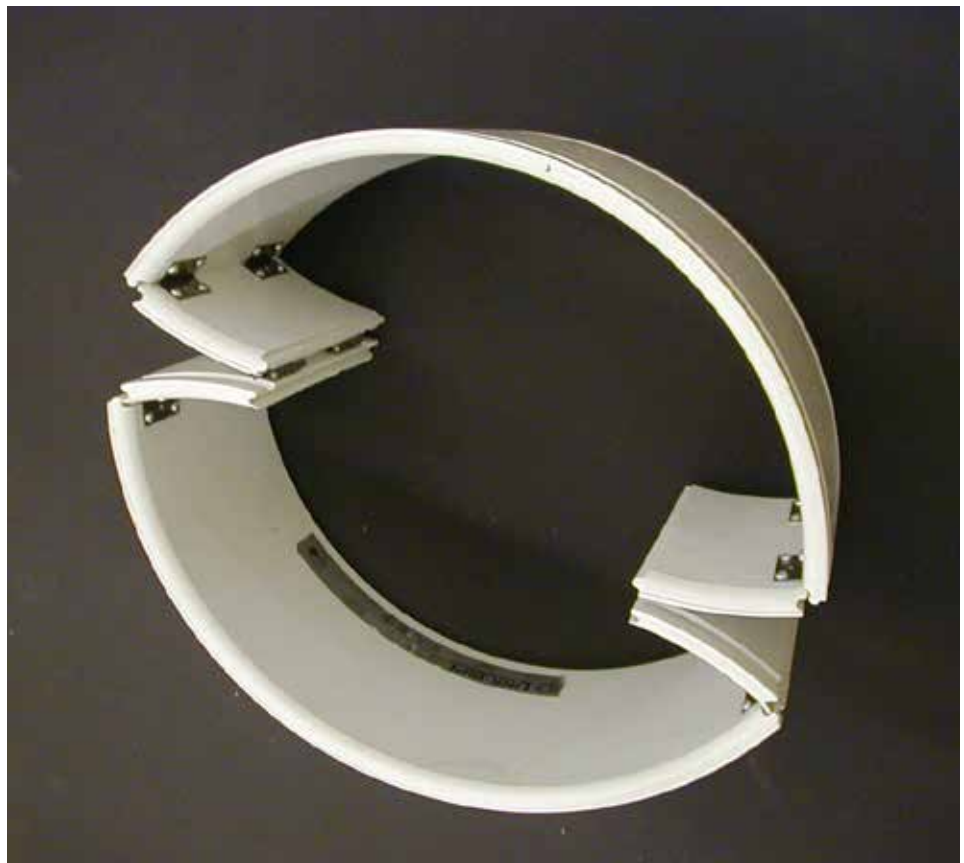
Figure 18—Polyvinyl chloride sleeve <<http://www.linkpipe.com>>.

Localized damaged areas within corrugated metal pipes can be repaired by applying prefabricated stainless steel or polyvinyl chloride sleeves. The sleeves come in various diameters and standard lengths (e.g., Link-Pipe™ polyvinyl sleeves are available in diameters from 36 to 108 inches with standard lengths of 18, 24, and 36 inches). Although multiple adjacent sleeves can be used, this method typically is used to repair relatively short sections of long culverts. They can repair structurally damaged culverts but also can be used to restore missing pipe sections without excavation or to provide infiltration sealing of joints. The sleeves are positioned inside the culvert while folded (figure 18) and jacked (snapped) into expanded shape.

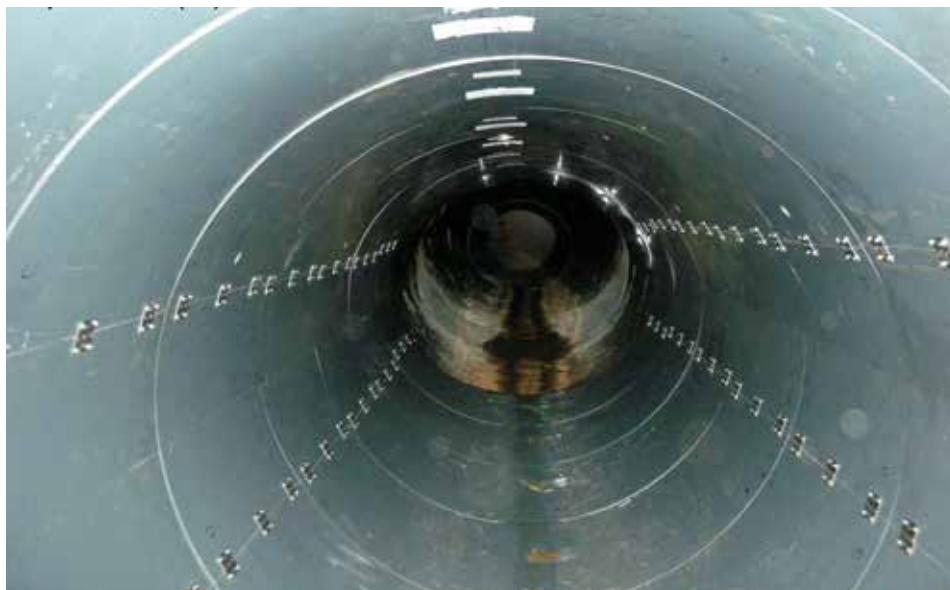
Figure 19—Polyvinyl chloride sleeve used in Atlanta, GA <<http://www.linkpipe.com/culverts.htm>>.

In 2007, in Atlanta, GA, a 60-foot long, 47-inch-diameter corrugated metal pipe was repaired (Link-Pipe polyvinyl sleeve) using multiple, back-to-back, polyvinyl chloride sleeves <<http://www.linkpipe.com/culverts.htm>>.

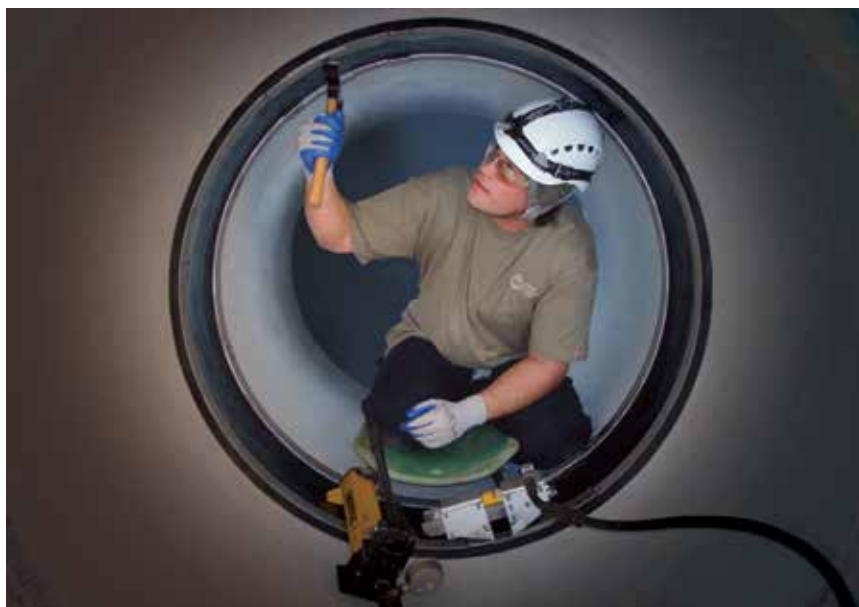
Figure 20—Internal joint sealing with flexible rubber seals (Miller Pipeline Corporation).

Individual leaking joints in man-entry corrugated metal pipes can be repaired effectively with flexible rubber seals. Such seals ensure a noncorrosive, bottle-tight connection around the full inside circumference of the pipe joint area (figure 20).

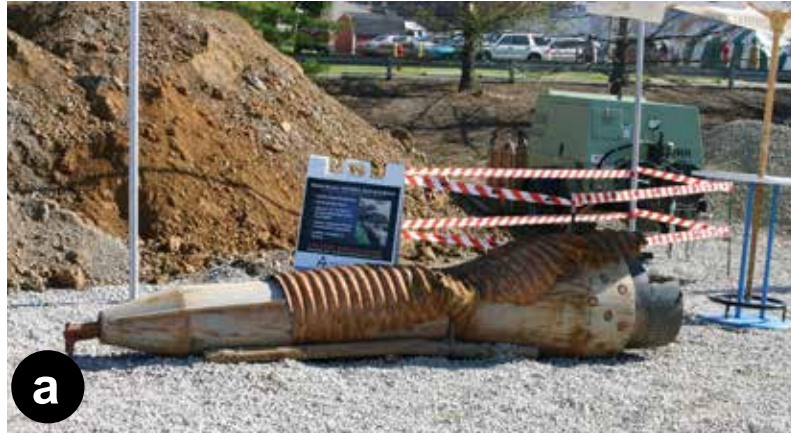
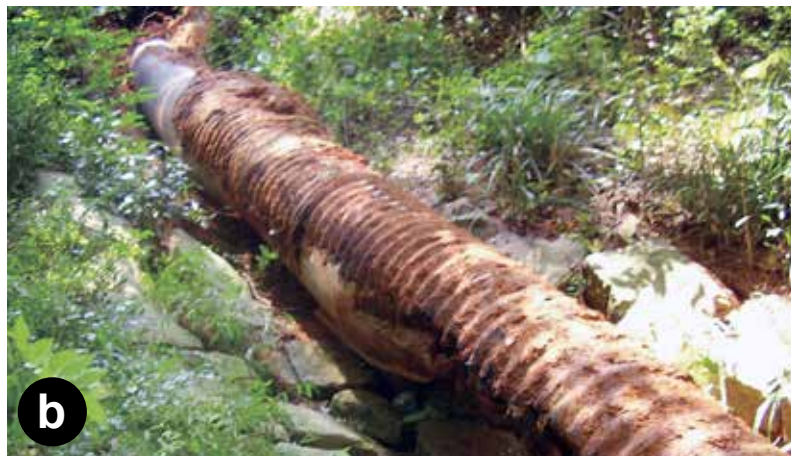
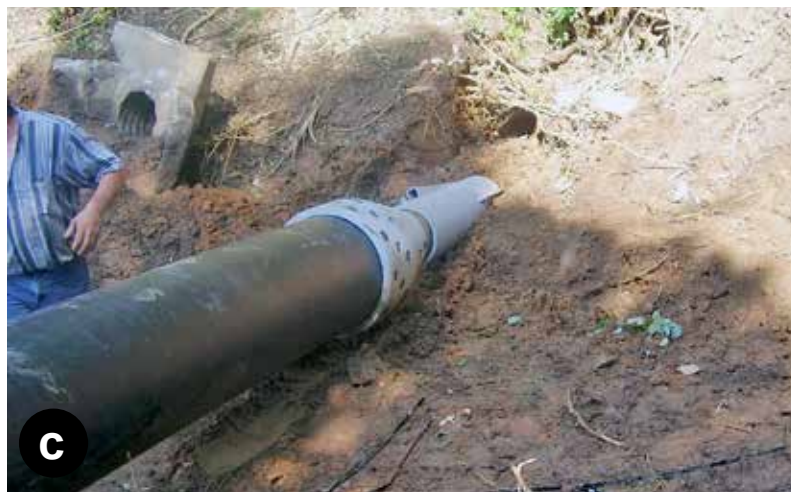
Figure 21—Bursting (TT Technologies)—a. Bursting head with cutting sleeve and rear expander (TT Technologies), b. Pipe bursting/pipe splitting of a corrugated metal culvert, c. Pipe bursting with an upsized of a culvert.

In 2005, DeKalb County, GA, reports having burst a 10-foot-long 15-inch-diameter corrugated metal pipe using a 14-inch Grundocrack Koloss with a 24-inch rear expander. It was upsized with a 24-inch high-density polyethylene pipe (figure 21). The original corrugated metal pipe culvert, sheared opened and expanded, remained in the ground except for the last 8-foot-long section, which was pushed out (Eddie Ward, personal communication).

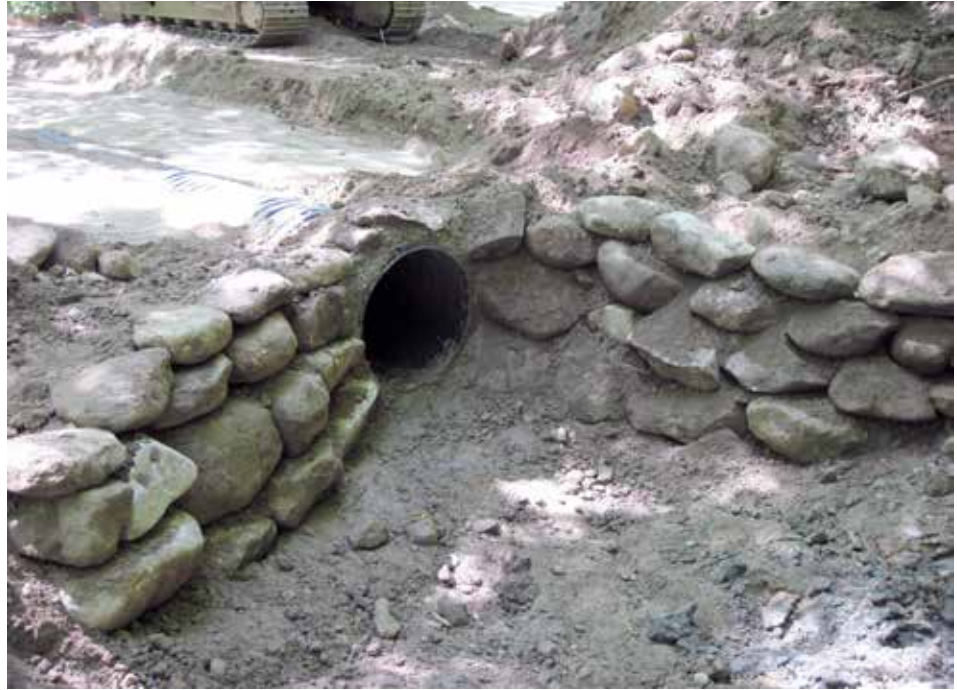
Figure 22—Conventional open-cut trench (Scott Kelman, Forest Service).

In some cases, a complete (conventional) open-cut replacement will be necessary to repair the highly corroded or collapsed corrugated metal pipe culvert structure. This construction method uses traditional and conventional means and is outside the scope of this report.

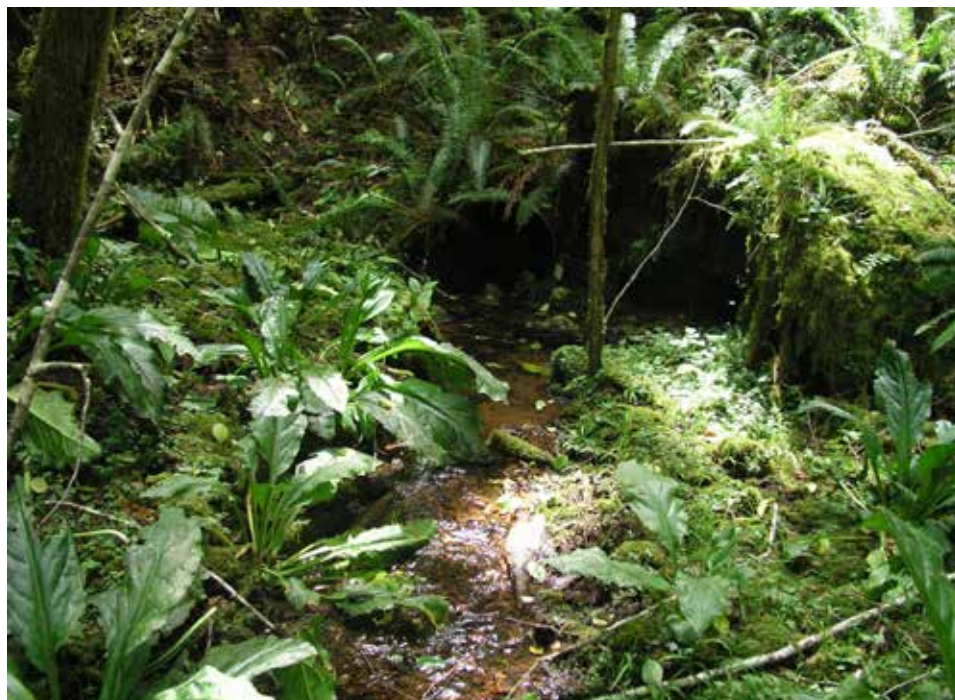
Figure B.1—Looking at the culvert inlet.

The photos in figures B.1 through B.4 were taken during a routine inspection:

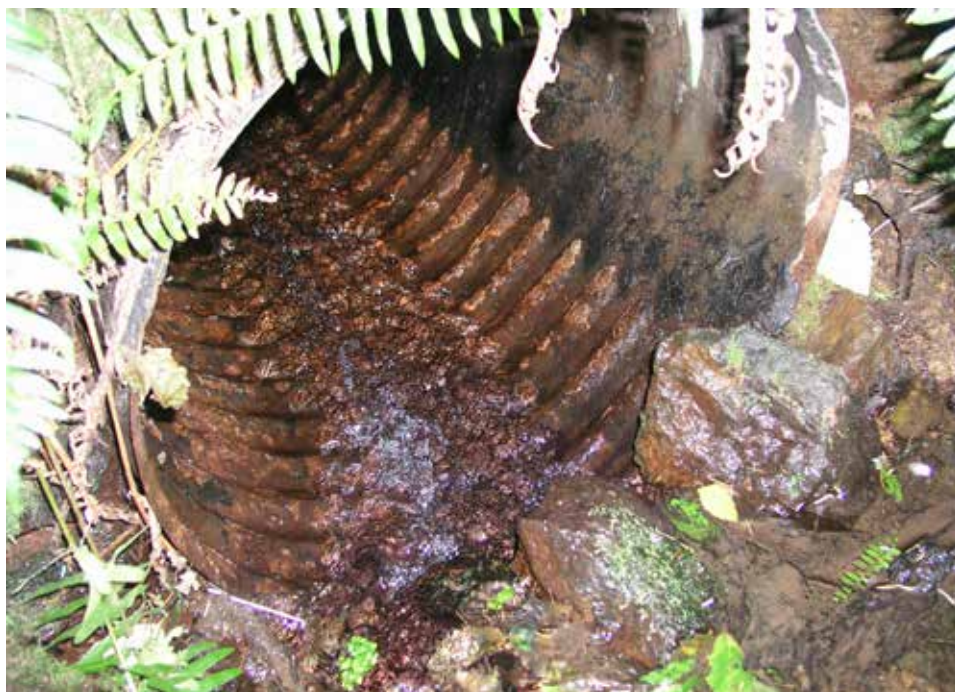
Figure B.2—Looking closely at the inlet of the 24-inch corrugated metal pipe.

A casual observer would likely assume that this old culvert on Road 1924 at milepost 0.1 is fine, but the Forest Service inspector looks closely to observe the pipe's condition.

Note that the culvert invert (bottom) has lost the bituminous coating and galvanizing due to scour and the steel is rusted (figures B.2 and B.3), but generally appears sound. Tapping on the steel with a hand pick confirms that this is true. The shape is normal (i.e., round). The pipe is nearly 140 feet in length, so even with a strong flashlight it is not possible to see the middle portion of the pipe. Also, note that no light is visible from the opposite end (figures B.3 and B.4). The apparent reason for this is that the pipe is sagging along its midportion, apparently due to settlement under the deep embankment (the ends are under a shallow embankment, so they have not settled). It is possible that during construction, the culvert was placed without the normally required camber, thus contributing to the sag. It is also possible that when this culvert was installed, insufficient care was given to subexcavating the weak organic soil overlaying the valley bottom and backfilling with incompressible aggregate bedding. The water drops from the outlet into a plug pool, but the standing water near the downstream third of the culvert (figure B.4) reinforces the belief that this pipe has an extreme belly in it.

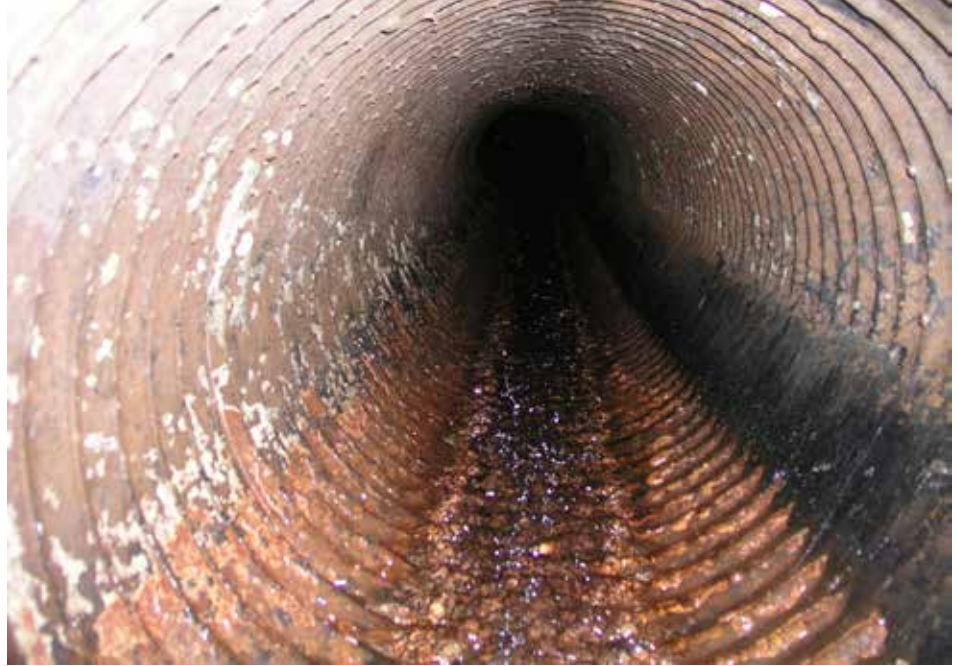
Figure B.3—Looking into the inlet using strong light.

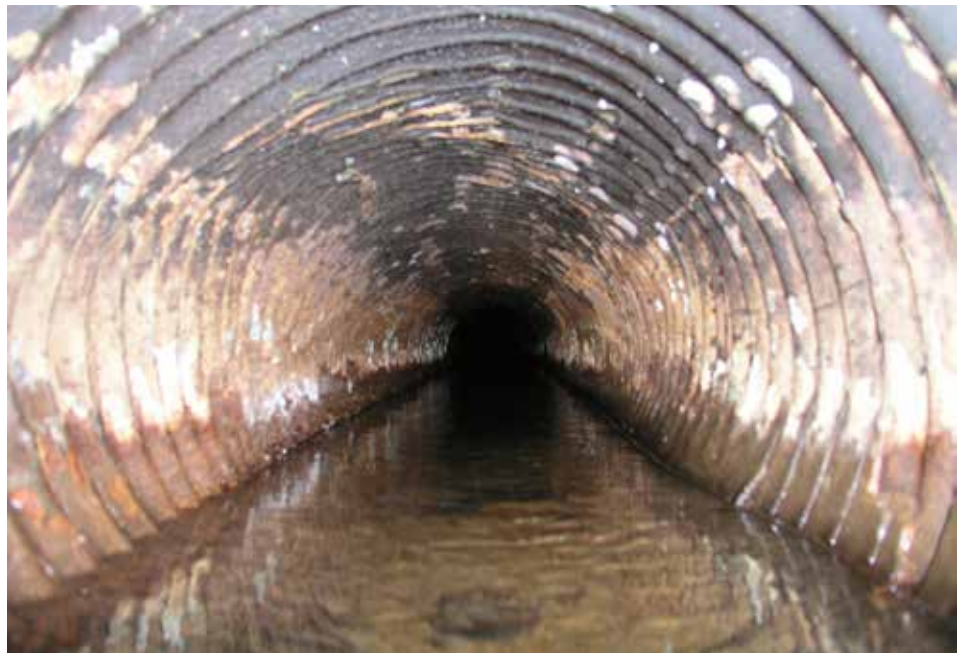
Figure B.4—Looking into the outlet using strong light.

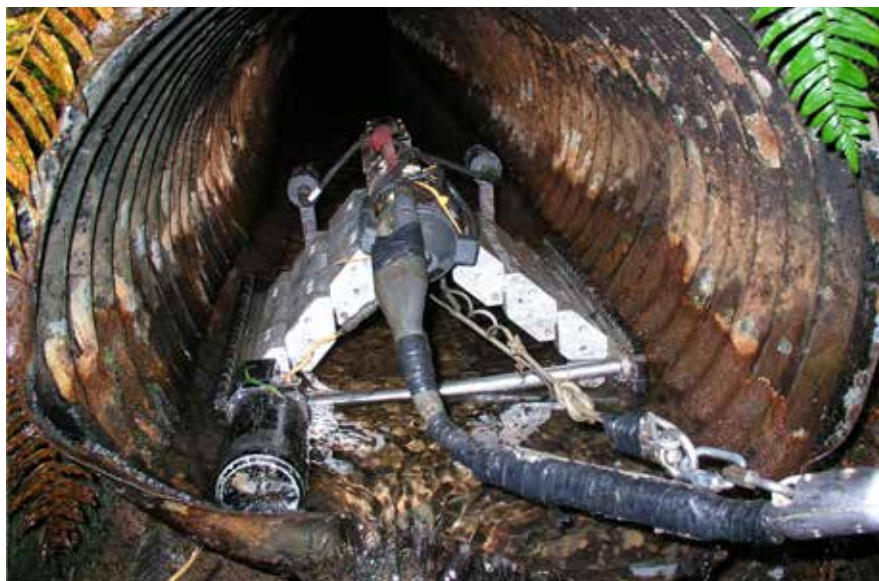
Figure B.5—Camera (with leg extensions) entering outfall.

The most critical portion of the pipe is along the middle third where the loading on the culvert is greatest. When the embankment is high, the pipe is typically too long to see the middle portion, as is the case with this pipe. Also, it is not safe to crawl down this pipe to take a closer look. Therefore, a contractor was hired to video the inside of the culvert (figures B.5 through B.8).

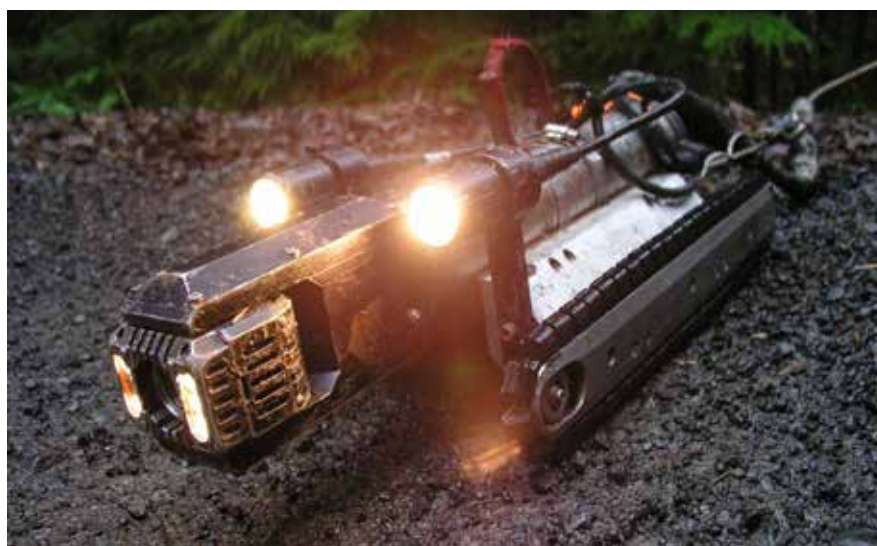
Figure B.6—Looking closed circuit television camera on roadway.

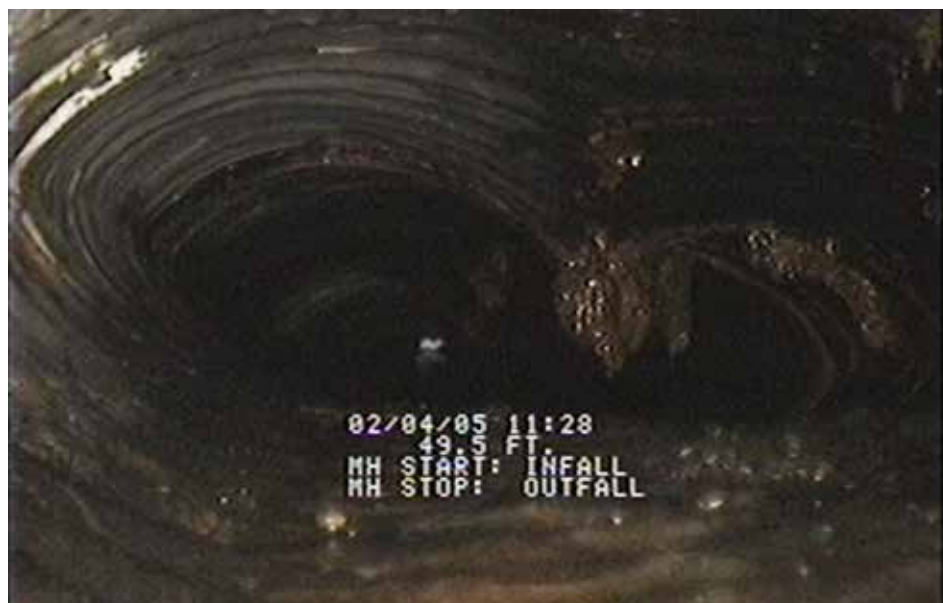
Figure B.7—Inside the culvert looking upstream, 50 feet from the inlet, Road 1924 milepost 0.1.

Photos in figures B.7 and B.8 were taken from the closed circuit television footage.

As seen from the closed circuit television images, this culvert has failed. The corrugated steel has buckled on the top, bottom, and both sides. The vertical space on one side is about 8 to 9 inches (on the left in figure B.9), and the vertical space of the opposite side of the pipe is about 4 inches. The top of the culvert is being forced downward by the weight of the roadway embankment, estimated to be about 3,800 pounds per cubic foot. The top has split and minerals are forming as soil is washed into the pipe from above. Note that water is running off the stalactite (figure B.9), indicating that the water table outside the culvert is above the pipe, probably due to streamwater flowing along a porous annular space outside of the pipe. (Note that 2005 was a very dry winter in this area.) The bottom of the corrugated steel is split and buckling upward because of horizontal soil forces and a weak invert. The lateral edges of the steel are creased, and the top and bottom are bending inward around the creases.
